Planning Commission Agenda Report

Meeting Date: March 22, 2018

SUBJECT: DISCUSSION OF ANNUAL COLLISION REVIEW
(Continued from February 22, 2018)

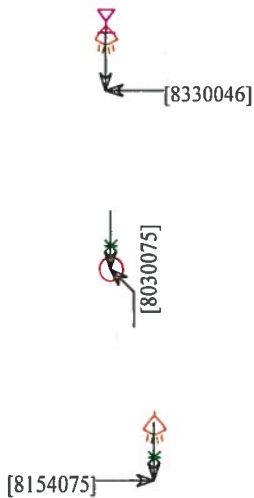
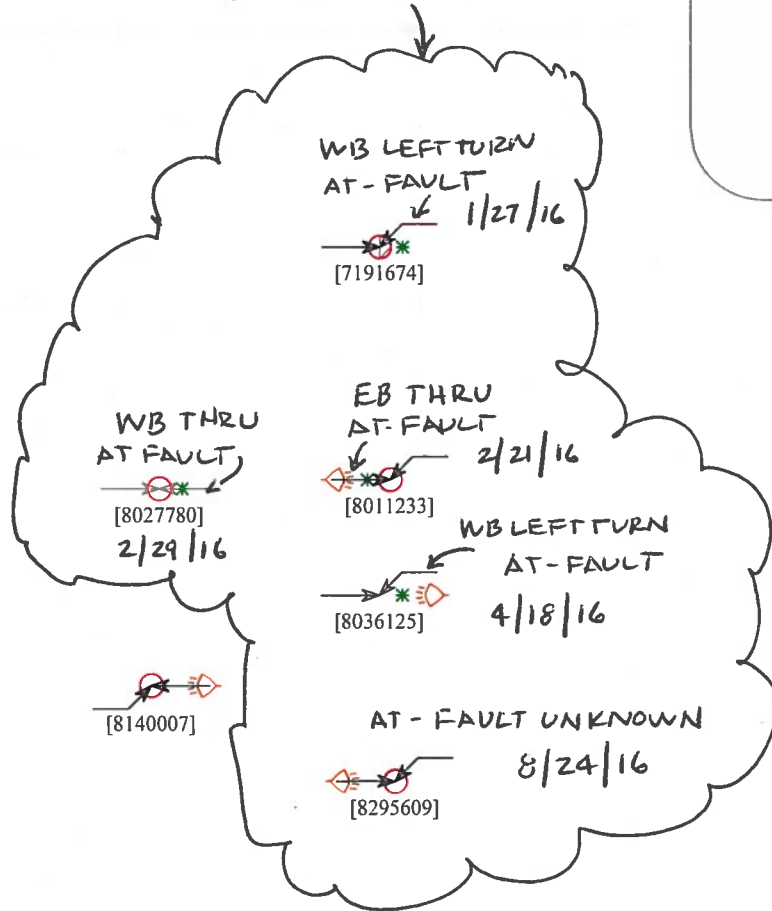
signal provides fully protected left turn phasing in all four directions. For 2016, a review of the base collision diagram indicated that there were 4 collisions involving westbound left turning vehicles and eastbound through vehicles. In addition, there was a head on collision involving an eastbound vehicle and a westbound vehicle that may have been coded incorrectly (it potentially involved a left turning vehicle). This many similar collisions suggested a potential pattern or trend, and, therefore, staff completed a more in depth review.

The more in depth review for this intersection found that for the 4 collisions involving left turning vehicles, 2 were caused by the left turning drivers, 1 was caused by the through driver, and 1 was of unknown cause (due to a lack of an independent witness). None of the 4 involved drivers under the influence. There was insufficient detail on the one head on collision to determine if it actually involved a left turning vehicle or not.

POTENTIAL
PATTERN

- Based on the overall conditions, staff is recommending an increase in the all-red from 1 to 1.5 seconds for the westbound left turn (2 seconds is considered the maximum). This would result in 0.5 seconds less green time for the movement, but would provide a small additional amount of clearance time (yellow plus all red). For uniformity this may require that the eastbound left also have the same all-red timing.

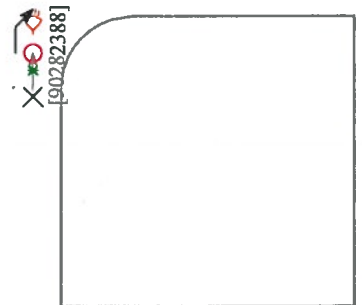
(0) crashes could not be placed in this schematic

- ← Straight
- ←| Stopped
- ← Unknown
- ↔ Backing
- ↔↔ Overtaking
- ↔↔ Sideswipe

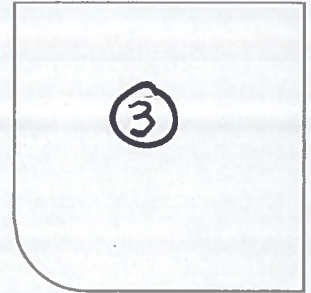
7 Crashes

Distance LTE 200

(0) crashes could not be placed in this schematic

- ← Straight
- ←| Stopped
- ← Unknown
- ↔ Backing
- ↔↔ Overtaking
- ↔↔ Sideswipe

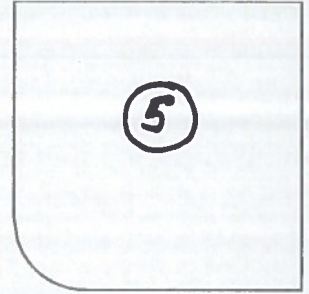
7 Crashes

Distance LTE 200

(0) crashes could not be placed in this schematic

- ← Straight
- ←| Stopped
- ← Unknown
- ↔ Backing
- ↔ Overtaking
- ↔ Sideswipe

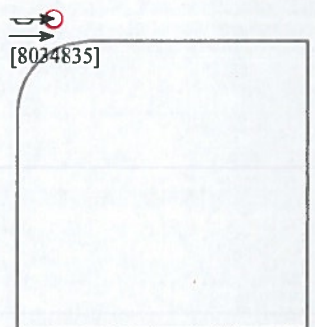
(0) crashes could not be placed in this schematic

- ← Straight
- ←| Stopped
- ← Unknown
- ↔ Backing
- ↔ Overtaking
- ↔ Sideswipe

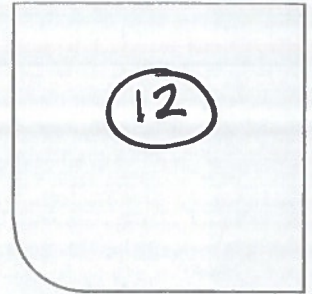
4 Crashes

Distance LTE 200

(0) crashes could not be placed in this schematic

- ← Straight
- ← Stopped
- ← Unknown
- ↔ Backing
- ↔ Overtaking
- ↔ Sideswipe

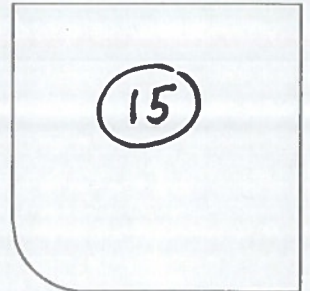
4 Crashes

Distance LTE 200

(0) crashes could not be placed in this schematic

- ← Straight
- ← Stopped
- ← Unknown
- ↔ Backing
- ↔ Overtaking
- ↔ Sideswipe

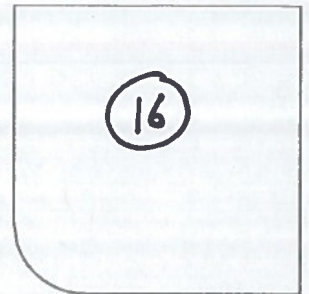
4 Crashes

Distance LTE 200

(0) crashes could not be placed in this schematic

- ← Straight
- ←| Stopped
- ← Unknown
- ↔ Backing
- ↔ Overtaking
- ↔ Sideswipe

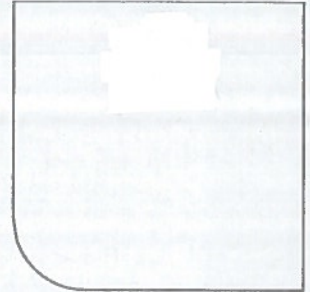
1 Crashes

Distance LTE 200

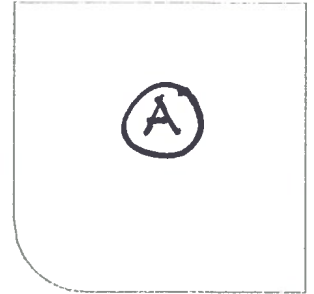
2 Crashes

Distance LTE 200

(0) crashes could not be placed in this schematic

- ← Straight
- ←| Stopped
- ←- - Unknown
- ↔ Backing
- ↔↔ Overtaking
- ↔↔ Sideswipe

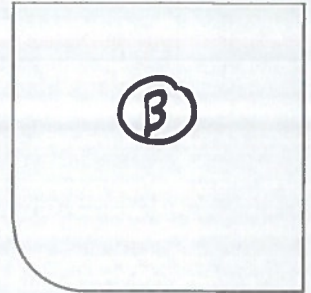
0 Crashes

Distance LTE 200

(0) crashes could not be placed in this schematic

- ← Straight
- ←| Stopped
- ← Unknown
- ↔ Backing
- ↔ Overtaking
- ↔ Sideswipe
